2.5 Liter Twin Cam Timing Belt Replacement

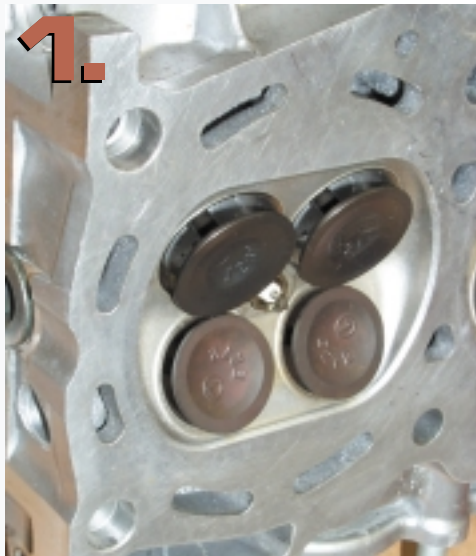
We've removed a 2.5 cylinder head to show just how crowded it is in the combustion chamber area. Each intake valve has its own cam lobe. The intake valve timing is slightly staggered, so one intake valve begins to open and close slightly ahead of its partner. If the intake and exhaust cams are allowed to get out of time in relation to one another, intake and exhaust valves will collide in the combustion chamber area. Intake valves in four-valve heads are necessarily small, and more easily damaged than similar components on two-valve engines. A collision between valves, even when the engine is not running (during a timing belt replacement for example), can cause valve damage. The object is to finish the job with the engine running at least as well as it was before you started, which is why it's so important to approach this job with the necessary caution and the proper tools.

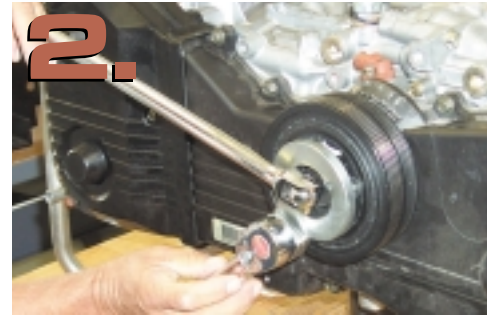
A three-piece outer belt cover set protects the timing belt. Fourteen bolts hold the covers in place. The left and right covers must be removed first, then the center section. Most of the bolts thread into captive nuts in the back sides of the cover set. Use a 1/4-inch drive socket set to remove the bolts and take your time. If the bolts feel tight, try tightening slightly before removing them. This will prevent damage to the captive nuts, which will make it easier to put the covers back in place and will make it easier for the next guy too.

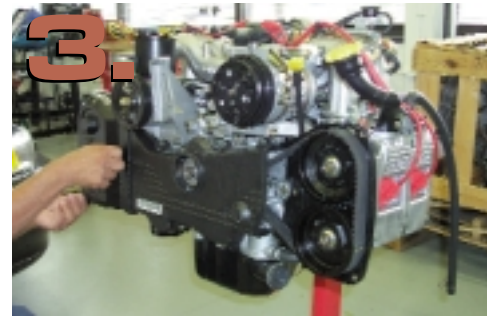
The covers are designed to seal out dirt and they must be properly reinstalled to do their job. Inspect the rubber gaskets which seal the inner to the outer covers. If they have become swollen due to oil leakage, find the source of the oil leak and replace the damaged gaskets before reinstalling the covers. Even a small amount of road grit inside the timing covers will act as an abrasive that will make short work of the timing belt, resin cam pulleys and other timing components.

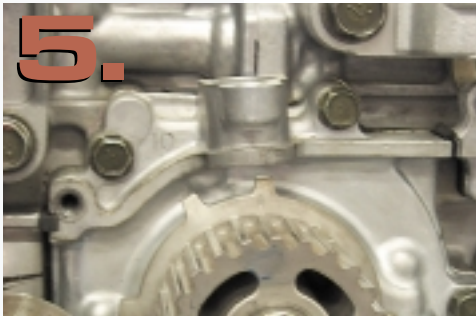
There are seven different timing marks that need to be in alignment. Close doesn't count here — we're not playing horseshoes. We'll start with the crankshaft pulley. Make sure the timing mark on the crankshaft reluctor is lined up with the corresponding mark on the engine case.

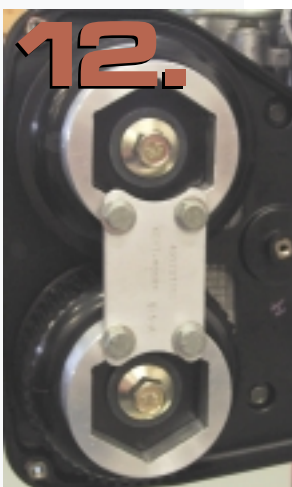
Okay, we're ready to blast off the old timing belt, right? Wrong! When the timing marks are in the proper position for belt replacement, several of the valves are either open or partially open. Removing the timing belt now will let the camshafts turn in a sudden and uncontrolled manner as the valve spring pressure causes the partially opened valves to slam shut. As these valves close, others will try to open. What can happen next? You guessed it — valve-to-valve interference. Before you can say 'Oops,' you could be looking at a few slightly tweaked valves. Not a pretty picture.

So do you put it all back together and close the hood? No. Not if you've got the proper tools. This tool fits over the large hexes on the upper and lower camshaft sprockets on the right side of the engine. The tool effectively locks the two sprockets together, keeping them from turning as long as it's in place.

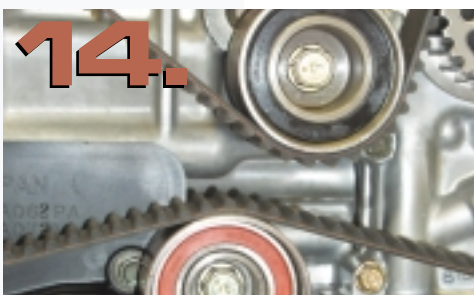
The 2.5 engine's timing belt must negotiate a combination of three idler pulleys, the water pump pulley and the tensioner pulley during each rotation. Pay particular attention to the position and appearance of the different idler pulleys, especially if you happen to remove more than one for any reason. They all look very similar to one another, but each pulley is designed for installation in a particular location. Different pulley colors may or may not be used in different locations, but this isn't necessarily a reliable guide, as the pulleys can still be accidentally installed in the wrong location. Incorrectly installed pulleys can make unusual noises and fail prematurely. To avoid confusion, mark the pulleys with an indelible marker with the letter 'T' for top of 'B' for bottom. It's a simple step that will buy you a lot of piece of mind.

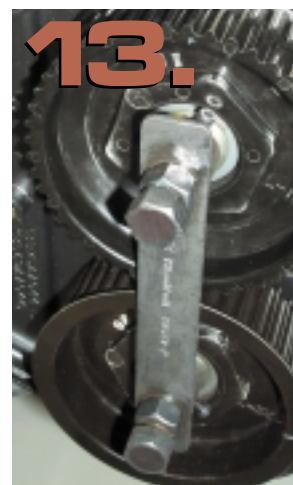
The idler pulley with the least amount of belt tension on it is the lower right idler pulley, which makes it the best candidate for removal when removing the timing belt. This is an all-aluminum engine, so it pays to be careful when removing and installing fasteners. Since the lower pulley isn't under a lot of stress, its mounting bolt can be removed and installed without risk of cross-threading or other damage.

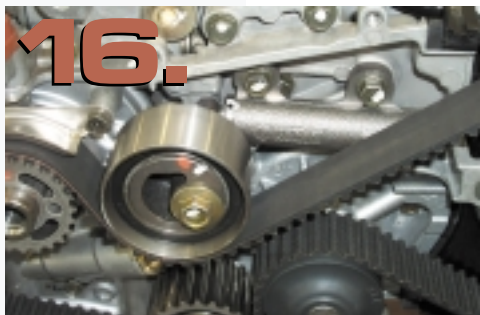
With the old timing belt out of the way, the next order of business is the timing belt tensioner. Two different types of hydraulic belt tensioners have been used on this engine. The early style is shown here. This is the same tensioner that was previously used on the 2.2 and 3.3 liter engines. Remove the tensioner from the engine, then carefully compress its adjuster rod in a vice equipped with soft-faced jaws. Use a small pin to hold the adjuster rod in its compressed position. The pin stays in until the timing belt installation procedure is complete.

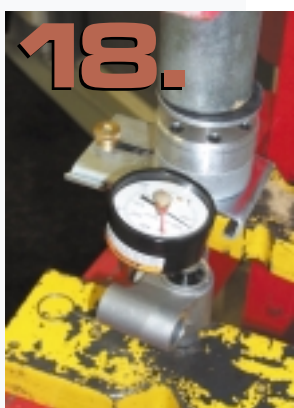
The tensioner rod must be compressed using a hydraulic press. The pressure exerted on the rod must not exceed 66 pounds. Exceeding this pressure may bend the tensioner rod. This will keep the rod from extending fully when it is reinstalled on the engine. If the rod cannot extend fully, excessive slack may develop in the timing belt, causing it to jump teeth. Jumped teeth can mean bent valves or damaged pistons, something you'll certainly want to avoid.

- Secure the tensioner in a press. This photo shows the recommended setup. An ABS brake pedal force gauge is inserted between the press rod and the adjuster piston. A small pin fits between the force gauge and the adjuster rod, assuring that all press force is directed to the adjuster rod. Use press plates to make sure the tensioner assembly is square and that no press force is directed to the tensioner pulley assembly.
- Slowly press the adjuster rod down to the end surface of the tensioner surface. Repeat this motion two or three times.
- Allow the adjuster rod to extend fully, then apply a pressure of 66 psi to the rod. Check the tensioner for resistance.
- If no resistance is felt and the adjuster rod moves down freely, replace the tensioner with a new one.
- Release the press and allow the adjuster rod to move up.

- Measure the extension of the adjuster rod beyond the body. Replace the tensioner if it is beyond the specification of $6.0 \text{ mm} \pm 0.5 \text{ mm}$.
- Check the condition of the tensioner and pulley contact surface, bearing operation and grease leakage. Replace the tensioner if any abnormality is found.
- If the tensioner passes inspection to this point, slowly move the rod down with a force of 66 pounds. Up to 10 minutes of slow pumps on the press lever may be necessary to fully retract the adjuster rod. Pump the lever until the pressure reaches 66 psi, then allow the pressure to drop before giving it another slow pump.
- Stop when the adjuster rod is fully retracted (flush with the tensioner body). Pushing beyond this point will damage the tensioner. A 2 mm retaining pin should fit easily through the holes in the tensioner housing and adjuster rod.

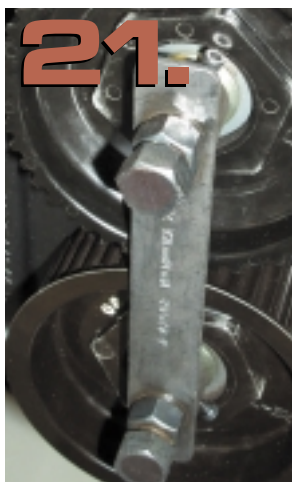
The holding tool on the left side of the engine is adjustable. Adjustment on this side of the engine is necessary because the tensioner is on the left side. Until the tensioner locking pin is removed, most of the belt slack will also be on this side of the engine. Counting the belt teeth and lining up the sprocket timing marks may produce what looks like a slightly 'wrong' lineup on the twin facing timing marks between the left cam sprockets. The problem is further aggravated by the fact that the holding tool blocks your view of the twin timing marks between the cam sprockets. If you've counted your teeth properly, all of the marks should come into alignment following the next couple of steps.

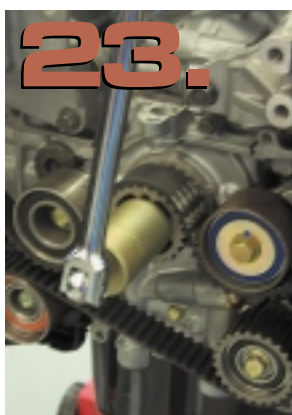
Remove both cam sprocket holding tools, then install the crankshaft turning socket. Turn the crankshaft 90 degrees counterclockwise, then 180 degrees clockwise, before returning the crankshaft sprocket to its alignment mark. This combination of movements allows the tensioner to take the slack out of the new belt and normalizes its position on the assortment of sprockets and idlers.

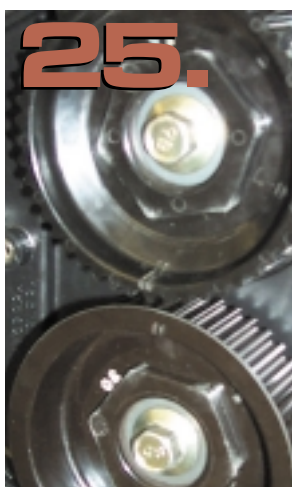
The timing marks on this engine lined up everywhere but here at the left cam sprocket match marks. After normalizing the belt by rotating it, the upper and lower pulley match marks didn't line up quite as precisely as we would have liked. The four marks didn't line up like four fingers pointing directly at each other. Rather, they lined up like four fingers pointing ever so slightly away from each other.

Subaru training instructor Joe Stoffa assured us that this was as close as we were going to get on this engine. Remember, four of the engine timing marks are simple notches in the inner timing cover plastic. Due to manufacturing tolerances and assembly variations, these notches may not end up in precisely the right spot. A slight variation here or there can add up to the slight misalignment we saw on our engine. Moving either of the pulleys a full tooth in either direction would not have corrected our perceived misalignment; it would only have made it worse.
